HISTORIC STRUCTURES REPORT

OLD PARISH HOUSE

CITY OF COLLEGE PARK

THOMAS J. TALTAVULL, ARCHITECT
©Copyright 2016
THOMAS J. TALTAVULL AND CITY OF COLLEGE PARK

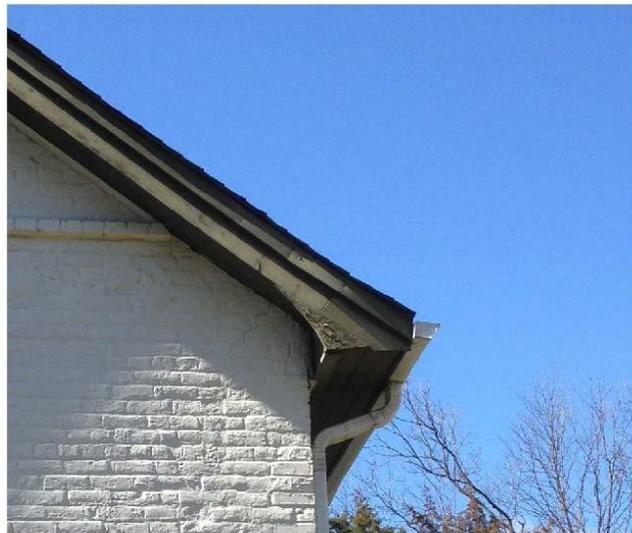
The wood rake, fascia and soffit boards appear to be from the Church Period 1897 – 1930. Generally the wood appears in good condition but shows some areas of cracking and decay. The paint and sealant are in fair condition.

Old Parish House, Exterior Trim Detail
Note Flaking Paint

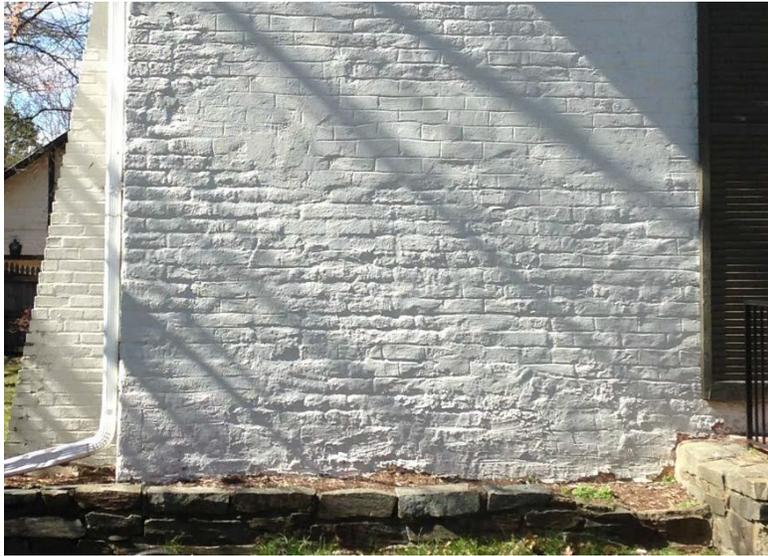
The historic brick masonry on the original portion of the building is in fair to poor condition in several areas. The brick has signs of deterioration in many areas due to age, weather and improper treatments. The age and location of the bricks in the wall has contributed to varying causes and severity of the deterioration. Bricks located close to the ground show more severe signs of blistering, spalling and mortar joint loss. These conditions are usually caused by moisture intrusion and freeze thaw conditions. There are several cracks in the walls in locations over windows on the south elevation due to outward forces on the walls from improper roof framing conditions. Also, the walls may have been weakened when the window openings were constructed when the building was converted to a church. The brick walls of the original main block have been painted at least two times. Visual observation in the attic area revealed a grey first coat. The second coat of white paint over the grey is currently on the exterior. The painting of the brick was possibly a first attempted preservation treatment as a protective coating to the soft porous masonry to keep out moisture or it may have been a purely decorative treatment. Another treatment of cement parging onto the outer surface of the brick on the east and south elevations were an attempt to halt the spalling brick in several locations.

Old Parish House East Elevation Detail
Brick Condition

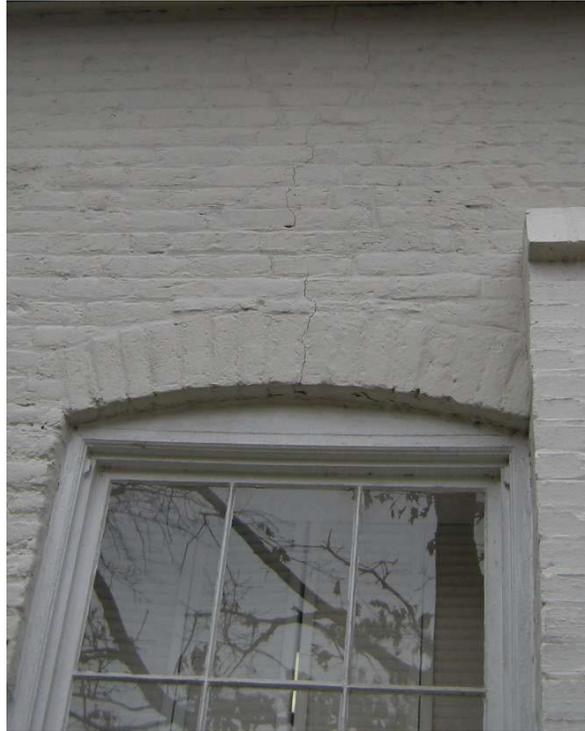
The masonry walls appear to be in good condition except the North and South walls of the main building. These walls are approximately 16 foot tall as measured from the grade on the outside. These brick walls are leaning / bulging outward in the magnitude of about 4" to 5" at the top of the wall in the center of the length of the building. Masonry buttresses are not original and have been added at some time in the past. There is some slippage between the buttresses and the walls. This slippage indicates some movement may still be occurring. These walls have been pushed outward. The cause of the movement appears to be that the roof structure is not properly tied to the wall.

Old Parish House, Masonry Crack over South Window, 2016

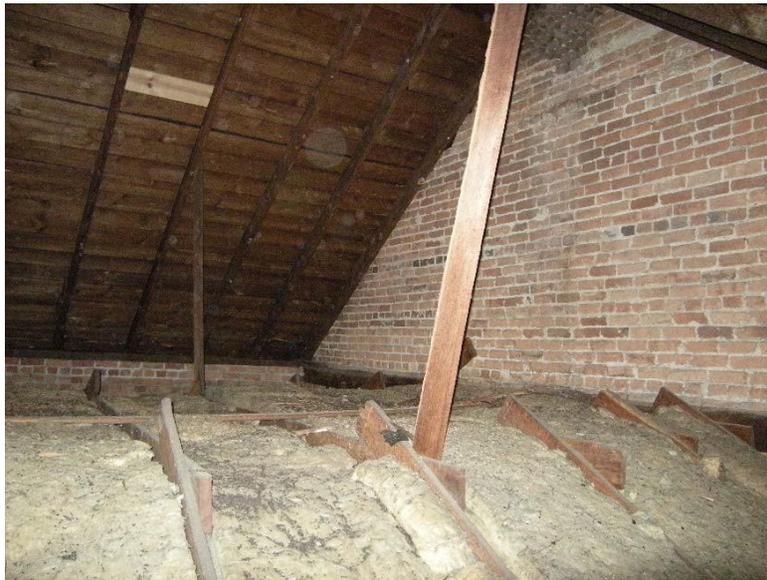
The roof framing in the main space is composed of 2x6 rafters at 28" +/- on center. These rafters are severely sagged indicating an overstressed condition. The ties tying them together may have slipped over time allowing the roof framing to push the masonry walls outward. Upon visual review of the attic space it appears that the roof framing, collar ties, ceiling framing, and hangers supporting the ceiling framing are all questionable with regard to their adequacy. Further

investigation and reinforcing of roof and ceiling structures should be done as soon as possible because they do not appear to be presently safe.

Old Parish House, Attic View, 2016

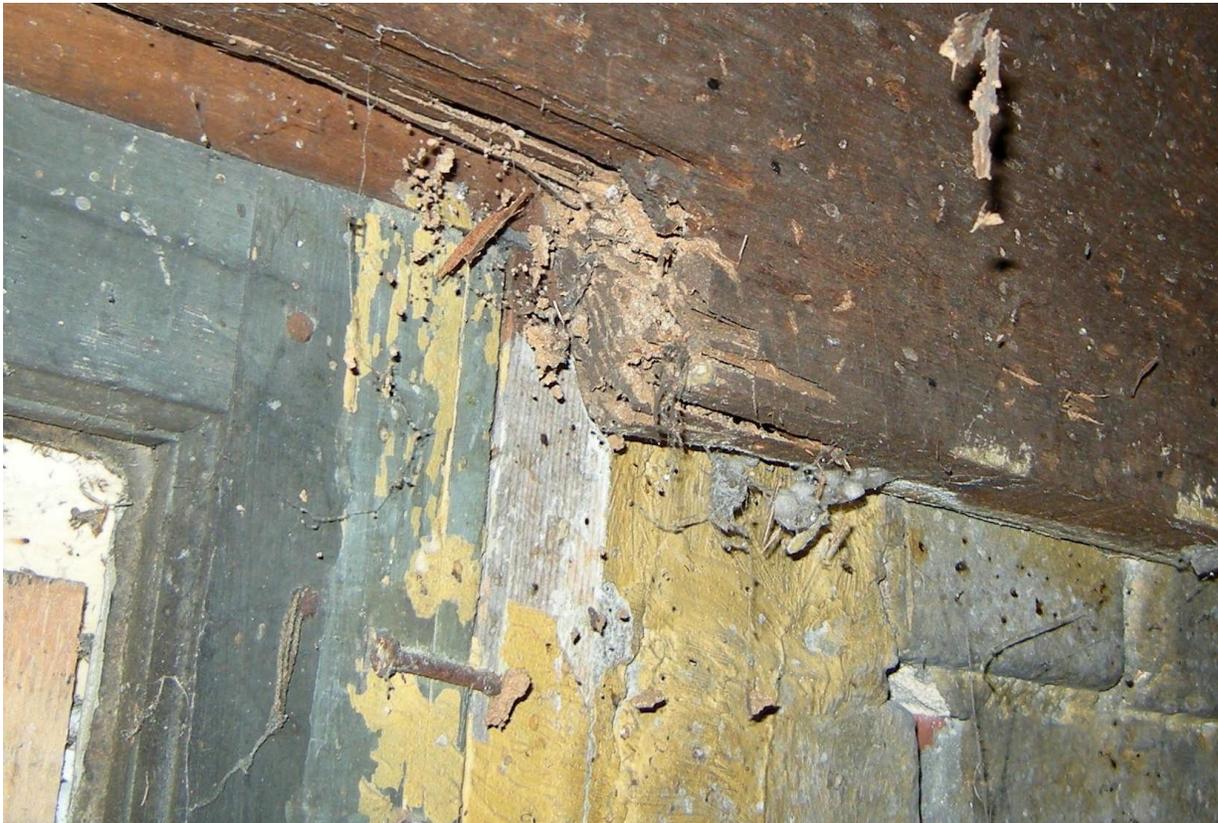
PHOTO #1 TERMITE DAMAGE

The floor framing below the sitting room is composed of 2x10 joists at 16 inches on center running East/West. These joists span about 14'-3". The northernmost joist adjacent to the north wall showed some termite damage. A termite inspection is recommended if this issue has not been previously addressed.

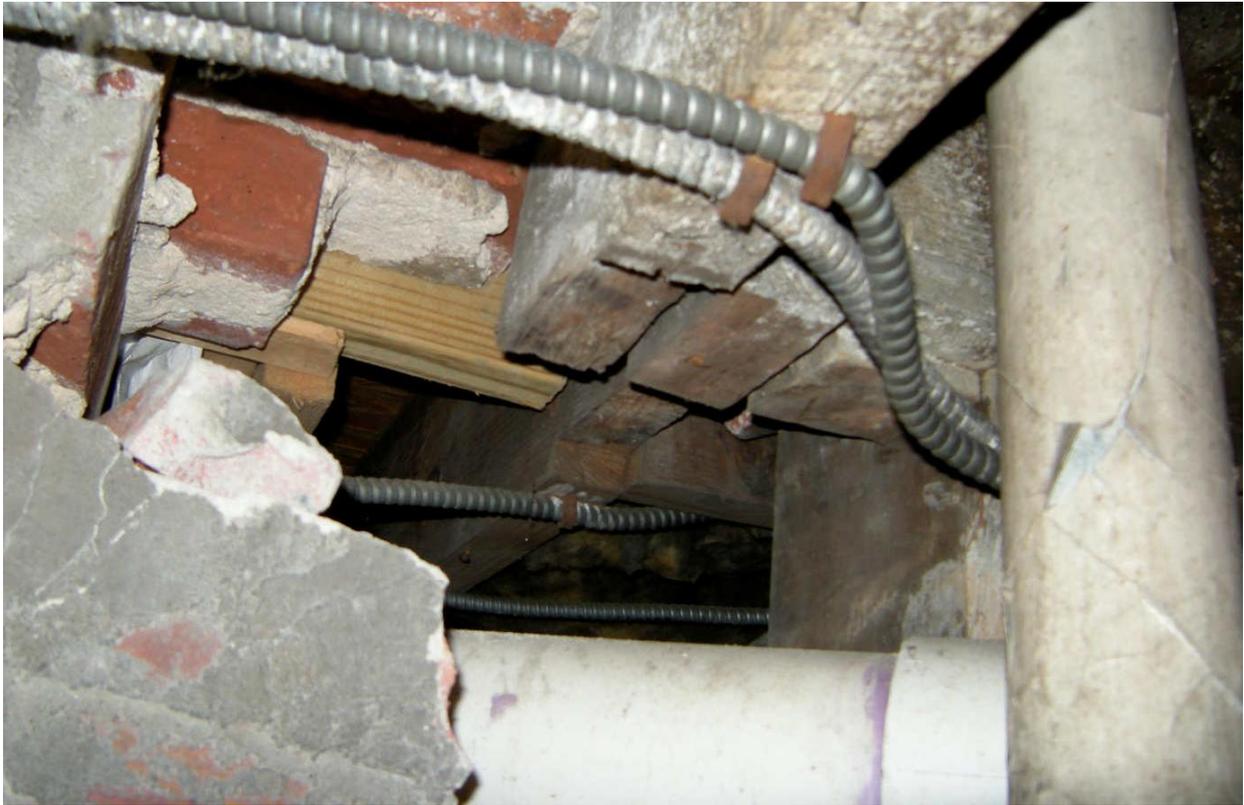
PHOTO #2 UNSUPPORTED JOISTS

Under the kitchen the joists appear to be 2x8 at 24 inches on center running East-West spanning approximately 11'-9" (only a few joists could be seen). At the opening between the crawl space under the kitchen and the basement area under the sitting room two joists have been undermined. Evidently when some plumbing work was done a portion of the masonry wall was removed. These joists are not properly supported and will require repair or replacement. The first floor of the large main room is a concrete slab. This slab spans to a center masonry wall running east/west. There were no signs noted of the slab being distressed and appears to be in sound condition. The thickness of slab, quality of concrete, and amount of reinforcing are unknown. The capacity of this slab is unknown and not easily determined.

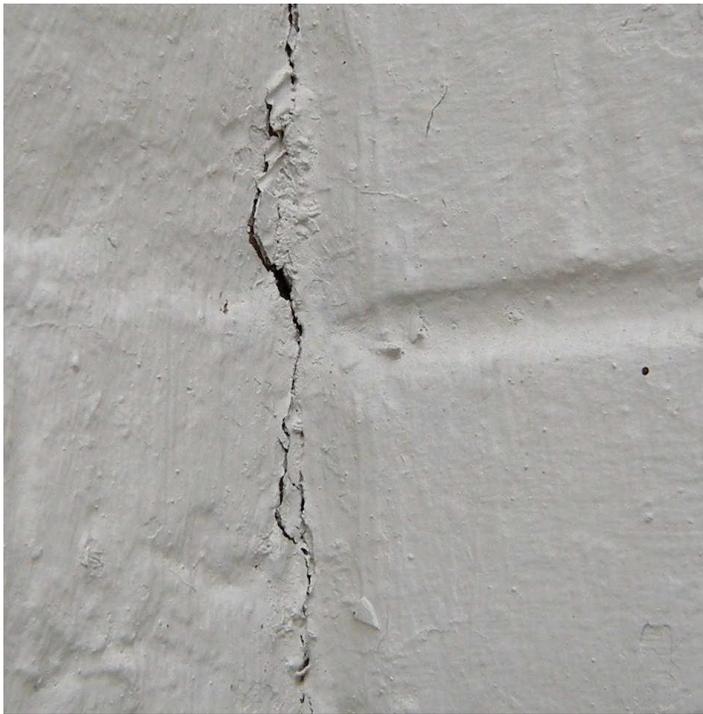
PHOTO #3 BUTTRESS SLIPPAGE

This slippage indicates some movement may still be occurring. These walls have been pushed outward. The cause of the movement appears to be that the roof structure is not properly tied as well as it should be.

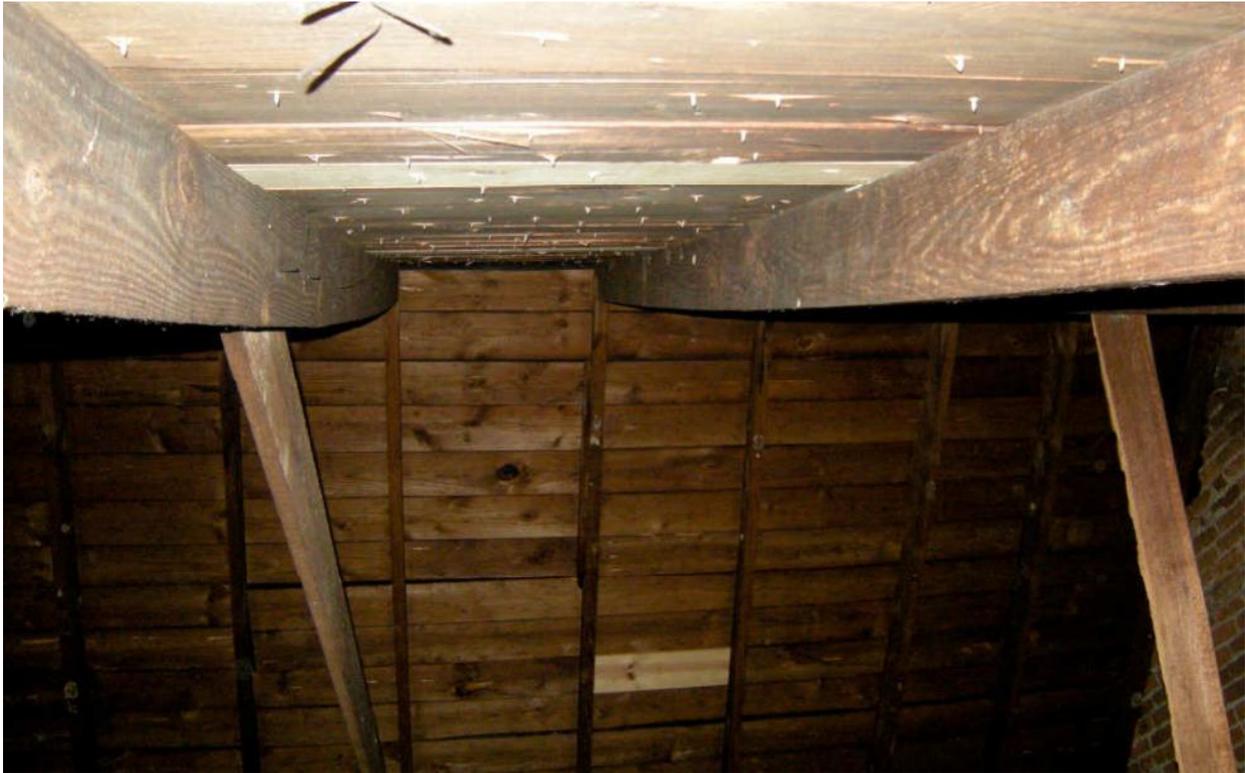
PHOTO #4 SAGGING RAFTERS

4. **Roof Structure** - of the main space is composed of 2X6 rafters at 28" +/- on center. These rafters are severely sagged indicating an overstressed condition. The ties tying them together may have slipped over time allowing the roof framing to push the masonry walls outward. Upon visual review of the attic space it appears that the roof framing, collar ties, ceiling framing, and hangers supporting the ceiling framing are all questionable with regard to their adequacy. Further investigation and reinforcing of roof and ceiling structures should be done ASAP because they do not appear to be presently safe. SEE PHOTO #4
