HISTORIC STRUCTURES REPORT

OLD PARISH HOUSE

CITY OF COLLEGE PARK

THOMAS J. TALTAVULL, ARCHITECT
©Copyright 2016
THOMAS J. TALTAVULL AND CITY OF COLLEGE PARK

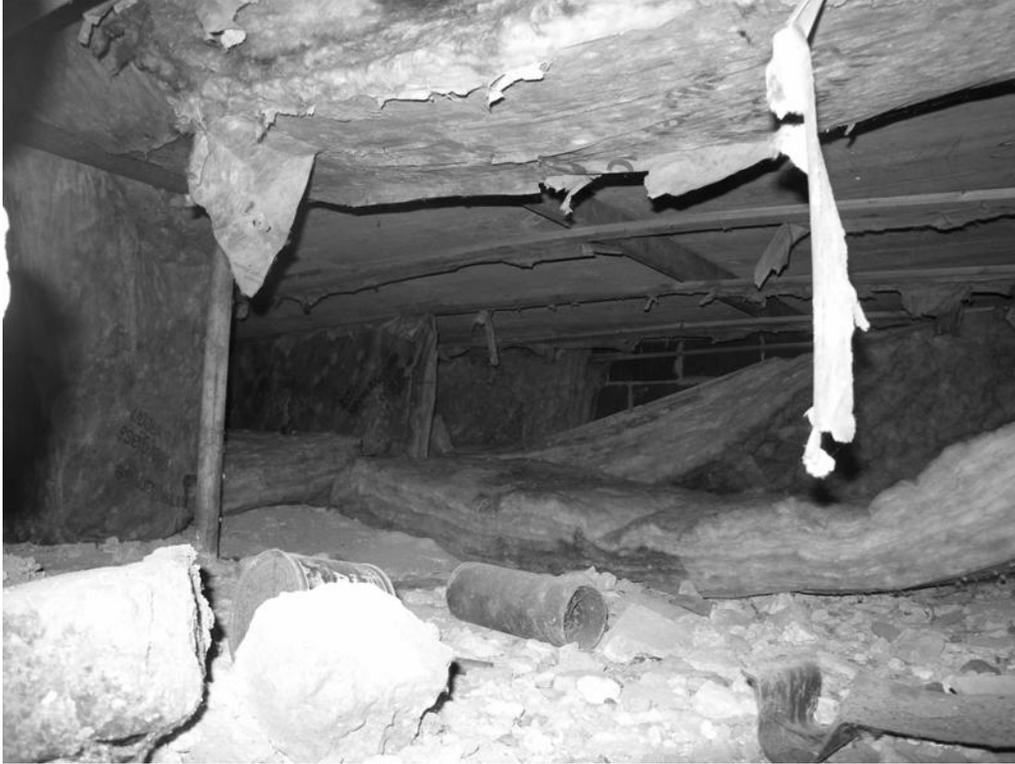
Old Parish House, Crawl Space under Main Hall. March 2016

The below grade areas of Old Parish House are made up of crawl spaces and a full basement area. The area under the main original block area currently is a crawl space with a dirt floor. Although access was limited a concrete masonry unit wall appears to run lengthwise down the middle of the space and is supporting a structural concrete floor. The exterior foundation walls were observed as being the original brick. Batt insulation was attached to the underside of the concrete floor. Electrical wiring and radiator piping were also present. The area under the west brick addition was not accessible but was observed to have similar conditions to the main block. There was a partial full basement under the brick entry wing. Originally, this area was built as a crawl space with brick foundation walls and exposed wood floor framing. The brick walls were underpinned with a concrete foundation wall to create a partial full basement when the frame kitchen addition was constructed. A concrete slab was poured and a bathroom was roughed in at the north east corner. Batt insulation is present between the floor joists. A gas fueled boiler, hot water heater and electrical panel are located in this basement area. A single light and switch are located in the basement. A floor drain is located near the wood basement door. The ceiling height in the basement area is six feet. The area under the frame addition is a low crawl space with an uncovered dirt floor. The foundation is concrete masonry unit construction with vents located in the framing. Batt insulation is present between the floor joists. Abandoned cast iron sewer piping and new PVC sewer piping were observed under the wood floor joists.

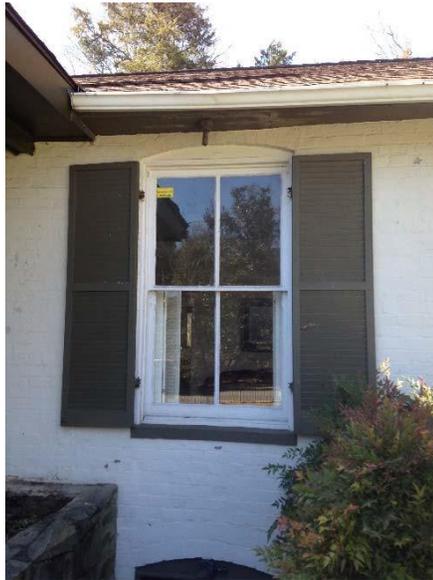
Old Parish House East Elevation of North Wing
Window Detail

The window and door openings currently located in the main block, not original to the building are in fair condition. The windows in the north entry and west chancel wing and are original and in good condition. The wood entry and screen doors are in good condition

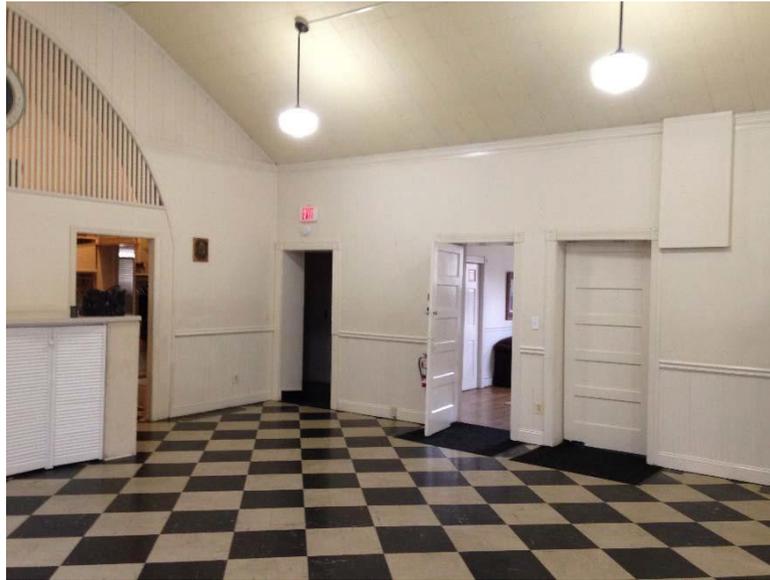
Old Parish House, Club Room,

- Floor: Concrete floor is in good condition. The 9" x 9" floor tiles are in fair condition and contain asbestos.
- Ceiling: White 12" x 12" acoustic ceiling tiles are in good condition.
- Walls: The wood triple beaded paneling wainscot and paneling is good condition.
- Baseboard: Wood 1 x 6 with ogee cap, no shoe mould, painted white is in good condition.
- Cornice: Wood Crown at top of wall, and Wood bed mould at gables are in good condition.
- Doors: The doors are good condition
- Windows: The windows are fair condition.
- Mechanical: The baseboard units are in fair condition. The single self-contained window air conditioning units are in good condition.
- Electrical: Ceiling mounted pendant lighting with glass globe are in good condition.

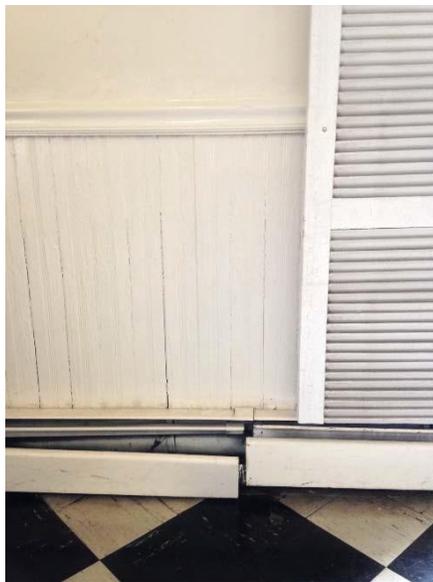
Old Parish House, Club Room,
East wall Detail.

The interior condition of the Old Parish House has been in continual use for most of the building's existence. This fact and the continual maintenance have kept the interior in good condition. Some moisture penetration along the south east wall have caused some damage to the wall paneling.
